Flood Control Project Maintenance
2013 Structure Summary Report
Overall Unit and Item Ratings

City of Sacramento

El Camino Avenue Bridge

Flood Control Project Maintenance**Unit Cover Sheet****2013 Structure Inspection Results****City of Sacramento**

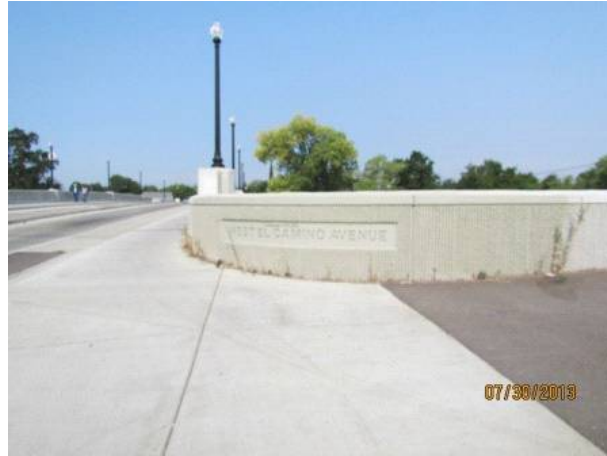
Levee Mile Report Line	1
Start Levee Mile	0.00
End Levee Mile	0.00
Location	
Category	Structures
Item	Photo Documentation

LMR No.	Levee Mile		Category	Item	Location *	Rating **	Action/Comment	GPS Latitude/Longitude		Issue No.
	Start	End						Start	End	Photo
1	0.00	0.00	Structures	Photo Documentation		N	Inspector Comments: West El Camino bridge is inspected as a structure because the bridge deck is below the design water surface elevation causing the wingwalls and guard railing to act as flood walls during high water events.	38.611365 ° -121.466557 °	38.611365 ° -121.466557 °	1 Y
2	0.00	0.00	Structures	Vegetation & Obstructions		A	Inspector Comments: The channel appeared to be free of any vegetation growth.	38.611365 ° -121.466557 °	38.611365 ° -121.466557 °	2 Y
3	0.00	0.00	Structures	Shoaling / Sedimentation		A	Inspector Comments: The channel didn't have any shoaling or sedimentation which would impede the flow.	38.611365 ° -121.466557 °	38.611365 ° -121.466557 °	3
4	0.00	0.00	Structures	Erosion / Bank Caving		A	Inspector Comments: No erosion or bank caving was found on the side of the channel.	38.611365 ° -121.466557 °	38.611365 ° -121.466557 °	4

View of the flood wall.

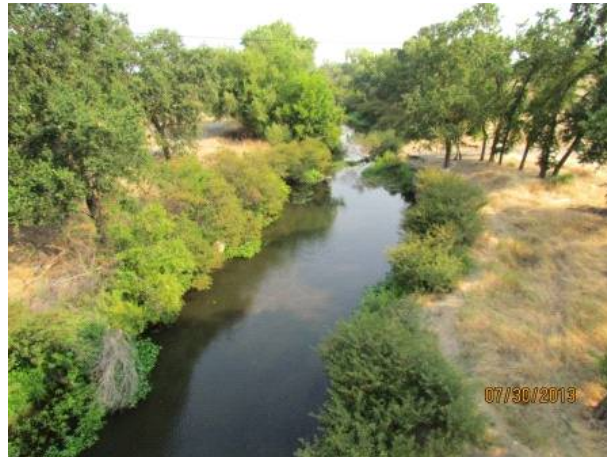
Levee Mile Report Line	2
Start Levee Mile	0.00
End Levee Mile	0.00
Location	
Category	Structures
Item	Vegetation & Obstructions

View of the channel under the bridge. The picture was taken looking upstream.

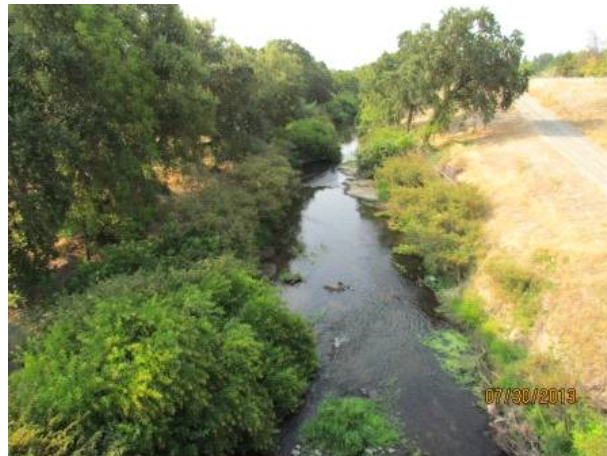
Levee Mile Report Line	2
Start Levee Mile	0.00
End Levee Mile	0.00
Location	
Category	Structures
Item	Vegetation & Obstructions

View of the channel under the bridge. The picture was taken looking downstream.

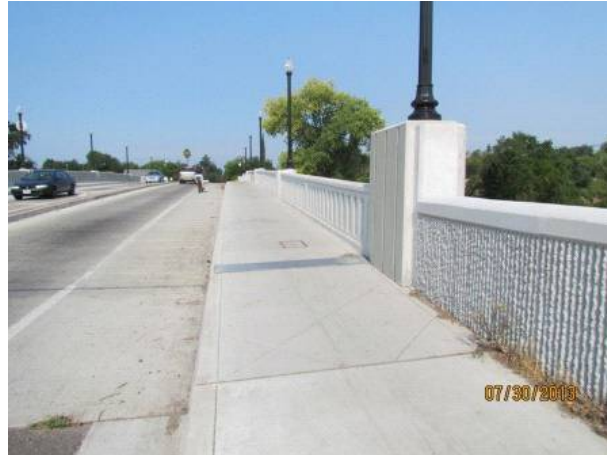
Levee Mile Report Line	15
Start Levee Mile	0.00
End Levee Mile	0.00
Location	
Category	Structures
Item	Concrete Surfaces

View of the flood wall.

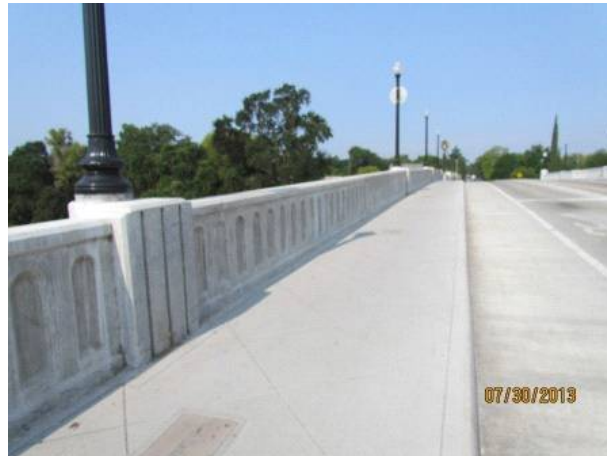
Levee Mile Report Line	15
Start Levee Mile	0.00
End Levee Mile	0.00
Location	
Category	Structures
Item	Concrete Surfaces

View of the flood wall.

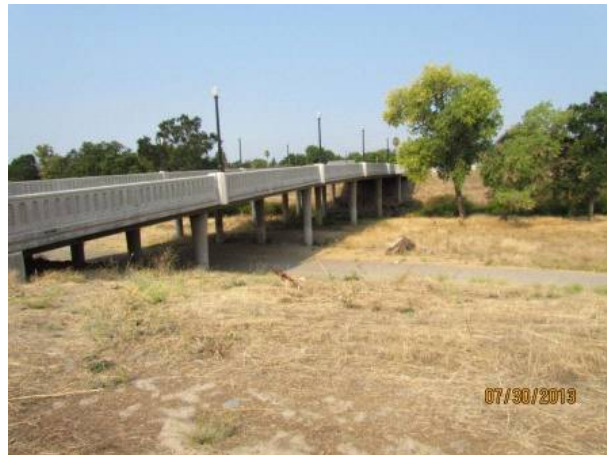
Levee Mile Report Line	17
Start Levee Mile	0.00
End Levee Mile	0.00
Location	
Category	Structures
Item	Concrete Foundations

LMR No.	Levee Mile		Category	Item	Location *	Rating **	Action/Comment	GPS Latitude/Longitude		Issue No.
	Start	End						Start	End	Photo
14	0.00	0.00	Structures	Manual Gate Operators		N	Inspector Comments: This item does not apply to this inspection.	38.611365 ° -121.466557 °	38.611365 ° -121.466557 °	14
15	0.00	0.00	Structures	Concrete Surfaces		A	Inspector Comments: The concrete surface didn't have any spalling or cracking which would threaten the integrity of the bridge.	38.611365 ° -121.466557 °	38.611365 ° -121.466557 °	15 Y
16	0.00	0.00	Structures	Concrete Tilting / Settlement		A	Inspector Comments: There were no signs of any settlement.	38.611365 ° -121.466557 °	38.611365 ° -121.466557 °	16
17	0.00	0.00	Structures	Concrete Foundations		A	Inspector Comments: No sign of scouring or erosion was visible at the footings of the structure.	38.611365 ° -121.466557 °	38.611365 ° -121.466557 °	17 Y

View below of the bridge.

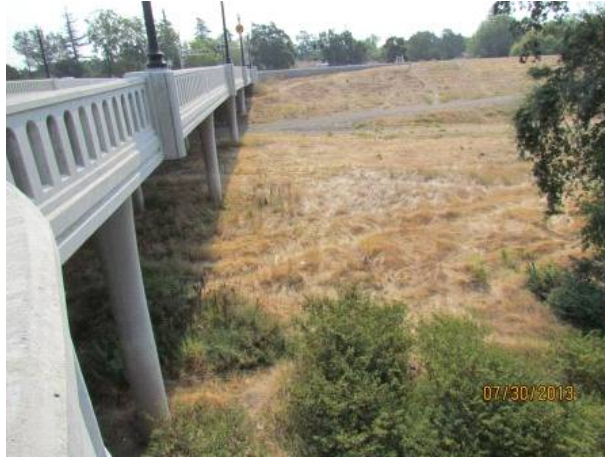
Levee Mile Report Line	17
Start Levee Mile	0.00
End Levee Mile	0.00
Location	
Category	Structures
Item	Concrete Foundations
View below of the bridge.	
pkazi_t_20130814_264.JPG

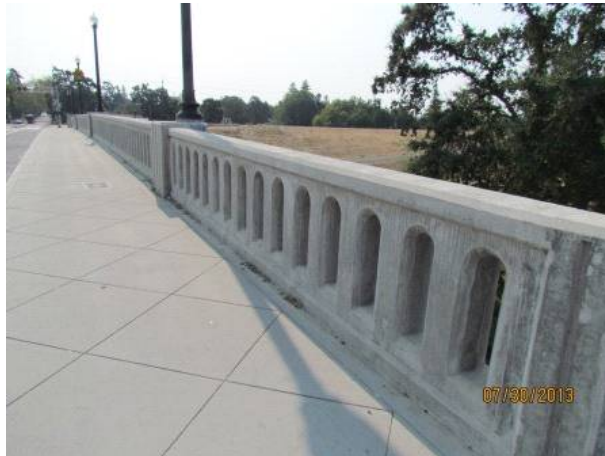
Levee Mile Report Line	22
Start Levee Mile	0.00
End Levee Mile	0.00
Location	
Category	Structures
Item	Monolith Joints
View of the flood walls with monolith joints.	
pkazi_t_20130814_265.JPG

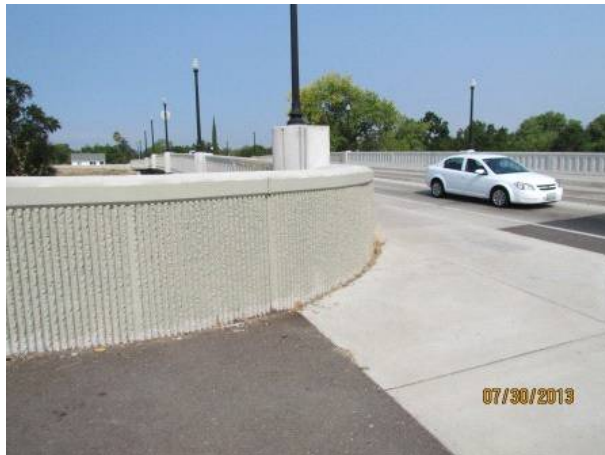
Levee Mile Report Line	22
Start Levee Mile	0.00
End Levee Mile	0.00
Location	
Category	Structures
Item	Monolith Joints
View of the flood walls with monolith joints.	
pkazi_t_20130814_266.JPG

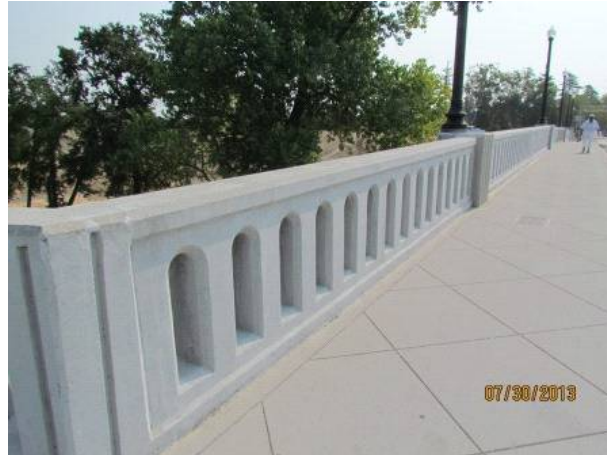
18	0.00	0.00	Structures	Security Fencing		N	Inspector Comments: This item does not apply to this inspection.	38.611365 ° -121.466557 °	38.611365 ° -121.466557 °	18
19	0.00	0.00	Structures	Closure Structures		N	Inspector Comments: This item does not apply to this inspection.	38.611365 ° -121.466557 °	38.611365 ° -121.466557 °	19
20	0.00	0.00	Structures	Trash Rakes		N	Inspector Comments: This item does not apply to this inspection.	38.611365 ° -121.466557 °	38.611365 ° -121.466557 °	20
21	0.00	0.00	Structures	Other Metallic Items		N	Inspector Comments: This item does not apply to this inspection.	38.611365 ° -121.466557 °	38.611365 ° -121.466557 °	21
22	0.00	0.00	Structures	Monolith Joints		A	Inspector Comments: The monolithic joint material was in good condition on the flood walls.	38.611365 ° -121.466557 °	38.611365 ° -121.466557 °	22 Y
23	0.00	0.00	Structures	Safety		A	Inspector Comments: The walls around the structure provide adequate protection against fall hazards.	38.611365 ° -121.466557 °	38.611365 ° -121.466557 °	23 Y

Levee Mile Report Line	23
Start Levee Mile	0.00
End Levee Mile	0.00
Location	
Category	Structures
Item	Safety
View of the flood walls which also provides protection against fall hazards.	
pkazi_t_20130814_267.JPG

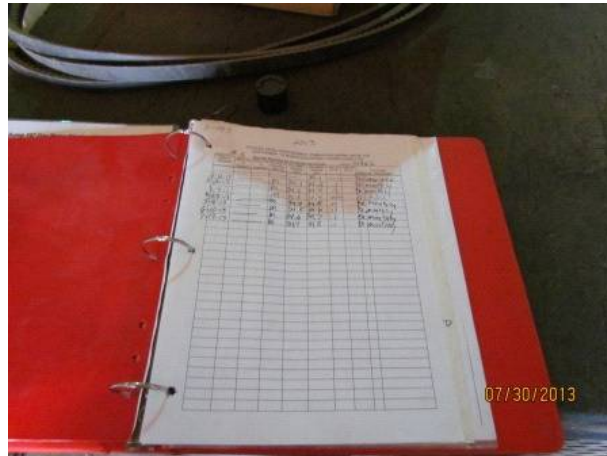
Levee Mile Report Line	1
Start Levee Mile	0.00
End Levee Mile	0.00
Location	
Category	Pump Stations
Item	Operating Log

LMR No.	Levee Mile		Category	Item	Location *	Rating **	Action/Comment	GPS Latitude/Longitude		Issue No. Photo
	Start	End						Start	End	
1	0.00	0.00	Pump Stations	Operating Log		A	Item inspected visually only. Item was not operated during the inspection. Inspector Comments: The operation log was maintained up to date and it was present at the pump station.	38.640967 ° -121.471106 °	38.640967 ° -121.471106 °	1 Y
2	0.00	0.00	Pump Stations	Operation & Maintenance Manual		U	Item inspected visually only. Item was not operated during the inspection. Inspector Comments: O&M Manual was not present inside the plant. DWR is also looking for a copy of the manual.	38.640967 ° -121.471106 °	38.640967 ° -121.471106 °	2
3	0.00	0.00	Pump Stations	Plant Building		A	Item inspected visually only. Item was not operated during the inspection. Inspector Comments: The plant building was in good condition without any visible cracks or structural damage.	38.640967 ° -121.471106 °	38.640967 ° -121.471106 °	3 Y

View of the maintenance log inside the pumping plant.

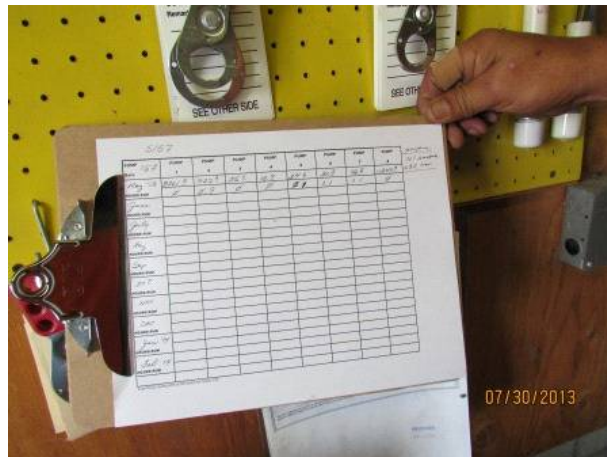
Levee Mile Report Line	1
Start Levee Mile	0.00
End Levee Mile	0.00
Location	
Category	Pump Stations
Item	Operating Log

View of the maintenance log in the operation room.

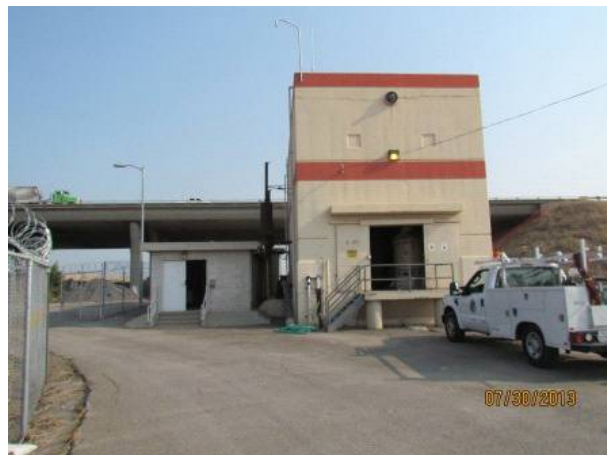
Levee Mile Report Line	3
Start Levee Mile	0.00
End Levee Mile	0.00
Location	
Category	Pump Stations
Item	Plant Building

View of the pumping plant and the control room.

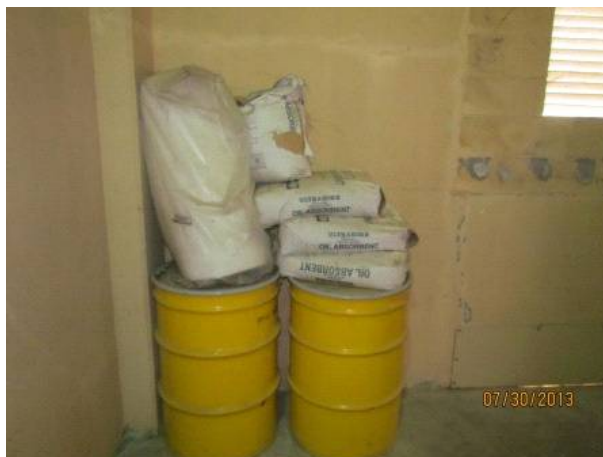
Levee Mile Report Line	5
Start Levee Mile	0.00
End Levee Mile	0.00
Location	
Category	Pump Stations
Item	Safety
Safety material for oil spills was present inside the pumping plant.	
pkazi_t_20130814_244.JPG

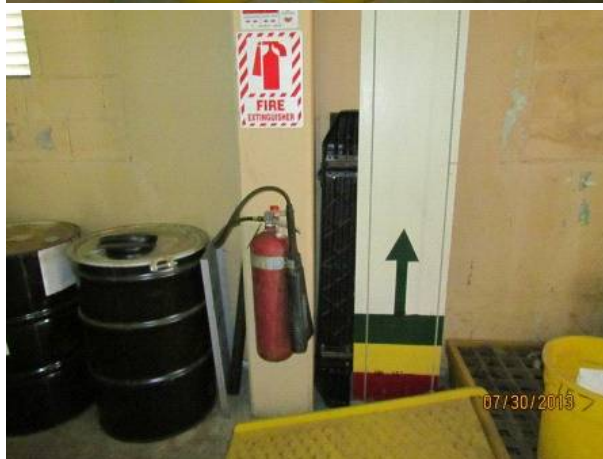
Levee Mile Report Line	5
Start Levee Mile	0.00
End Levee Mile	0.00
Location	
Category	Pump Stations
Item	Safety
View of the fire extinguisher inside the pumping plant.	
pkazi_t_20130814_245.JPG

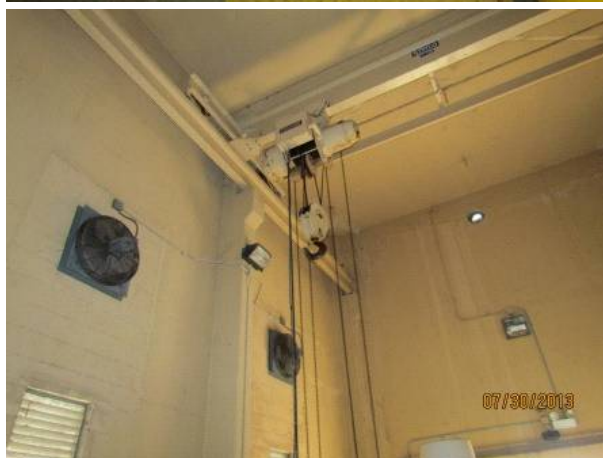
Levee Mile Report Line	6
Start Levee Mile	0.00
End Levee Mile	0.00
Location	
Category	Pump Stations
Item	Cranes
View of the crane inside the pumping plant.	
pkazi_t_20130814_246.JPG

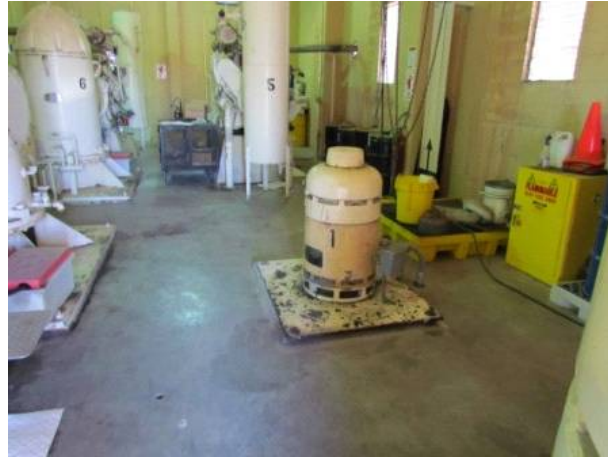
Levee Mile Report Line	7
Start Levee Mile	0.00
End Levee Mile	0.00
Location	
Category	Pump Stations
Item	Pumps

View of one of the electric pumps inside the plant.

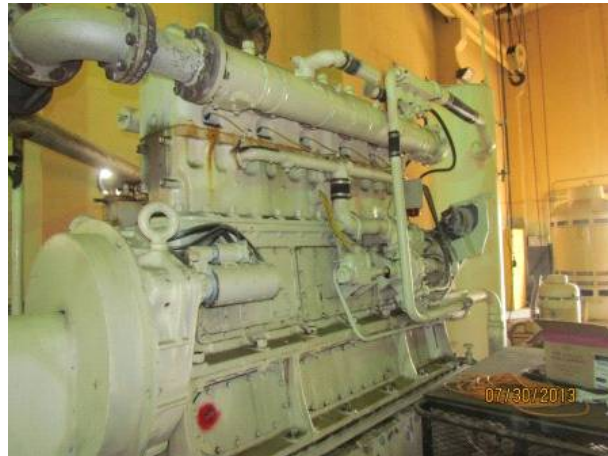
Levee Mile Report Line	7
Start Levee Mile	0.00
End Levee Mile	0.00
Location	
Category	Pump Stations
Item	Pumps

View of one of the propane powered pumps inside the plant.

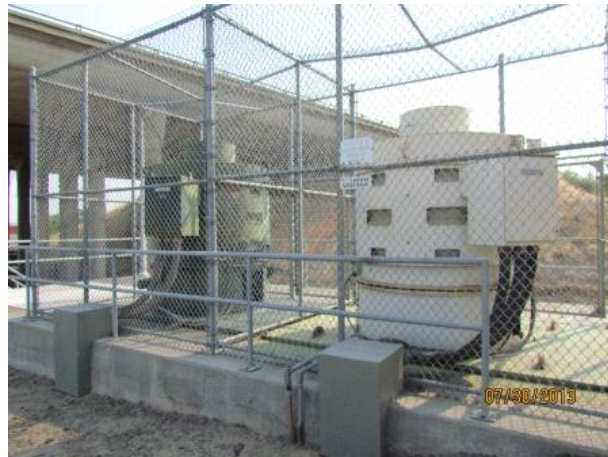
Levee Mile Report Line	7
Start Levee Mile	0.00
End Levee Mile	0.00
Location	
Category	Pump Stations
Item	Pumps

View of the electric pumps outside of the pumping plant.

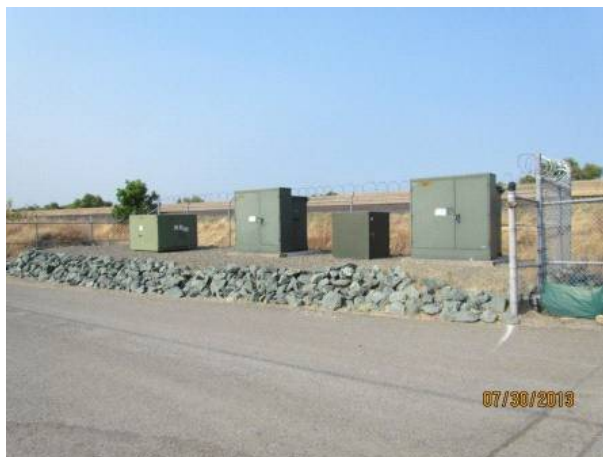
Levee Mile Report Line	8
Start Levee Mile	0.00
End Levee Mile	0.00
Location	
Category	Pump Stations
Item	Power

8	0.00	0.00	Pump Stations	Power		A	Item inspected visually only. Item was not operated during the inspection. Inspector Comments: The power sources appeared to be safe and reliable and some pumps are able to operate using propane as a fuel source.	38.640967 ° -121.471106 °	38.640967 ° -121.471106 °	8 Y
9	0.00	0.00	Pump Stations	Sluice / Slide Gates		A	Item inspected visually only. Item was not operated during the inspection. Inspector Comments: The slide gates were free of any debris and appears to be in a good working condition.	38.640967 ° -121.471106 °	38.640967 ° -121.471106 °	9
10	0.00	0.00	Pump Stations	Motors, Engines, Fans & Gear Reducers		A	Item inspected visually only. Item was not operated during the inspection. Inspector Comments: All the items appeared to be operational, and properly maintained.	38.640967 ° -121.471106 °	38.640967 ° -121.471106 °	10

View of the electrical boxes outside the pumping plant.

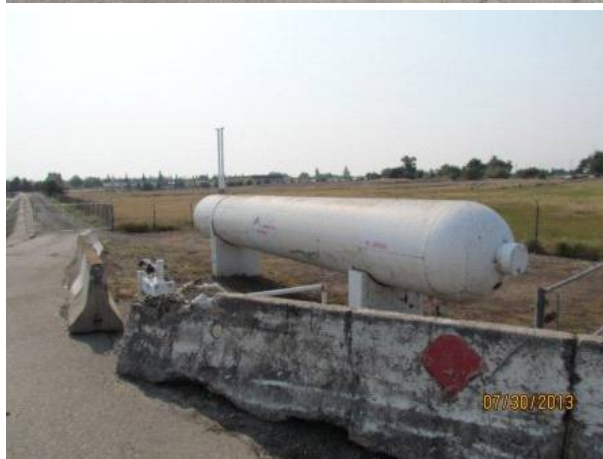
Levee Mile Report Line	8
Start Levee Mile	0.00
End Levee Mile	0.00
Location	
Category	Pump Stations
Item	Power

View of the propane tank outside the pumping plant.

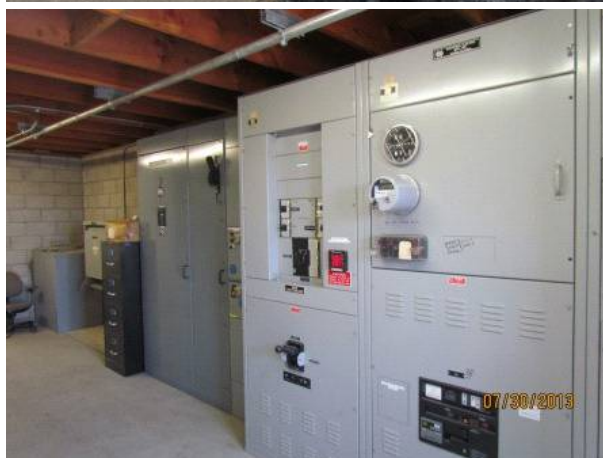
Levee Mile Report Line	11
Start Levee Mile	0.00
End Levee Mile	0.00
Location	
Category	Pump Stations
Item	Pump Control Systems

View of the pump control systems in the pump control building.

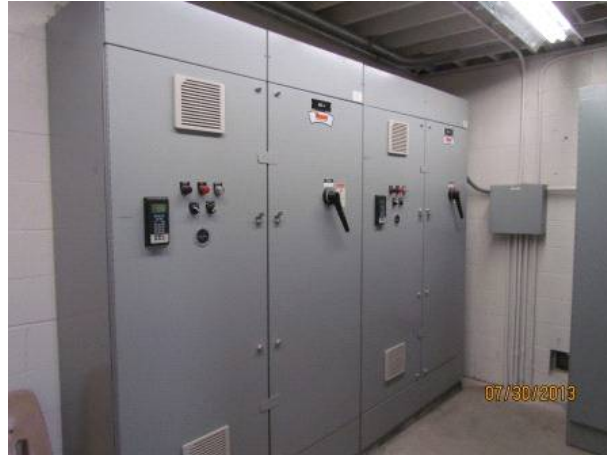
Levee Mile Report Line	11
Start Levee Mile	0.00
End Levee Mile	0.00
Location	
Category	Pump Stations
Item	Pump Control Systems
View of the pump control systems inside the control building.	
pkazi_t_20130814_252.JPG

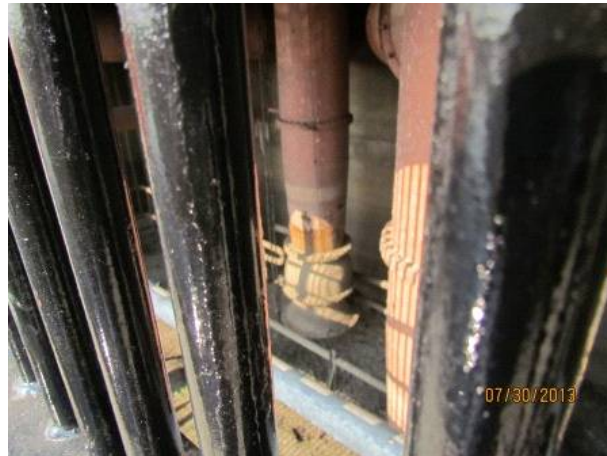
Levee Mile Report Line	12
Start Levee Mile	0.00
End Levee Mile	0.00
Location	
Category	Pump Stations
Item	Sumps/Wet Well
View of the wet well.	
pkazi_t_20130814_253.JPG

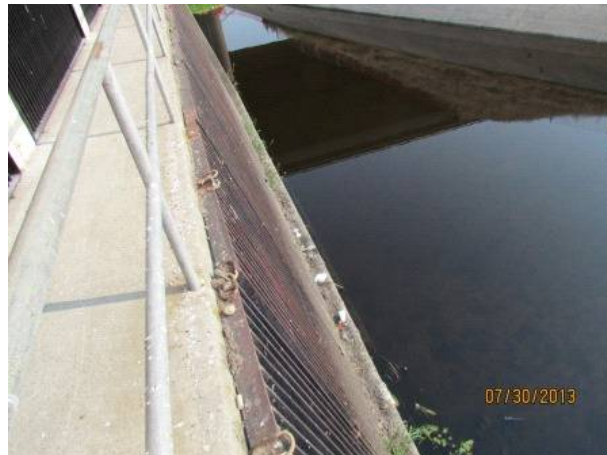
Levee Mile Report Line	13
Start Levee Mile	0.00
End Levee Mile	0.00
Location	
Category	Pump Stations
Item	Trash Racks
View of the trash rack.	
pkazi_t_20130814_254.JPG

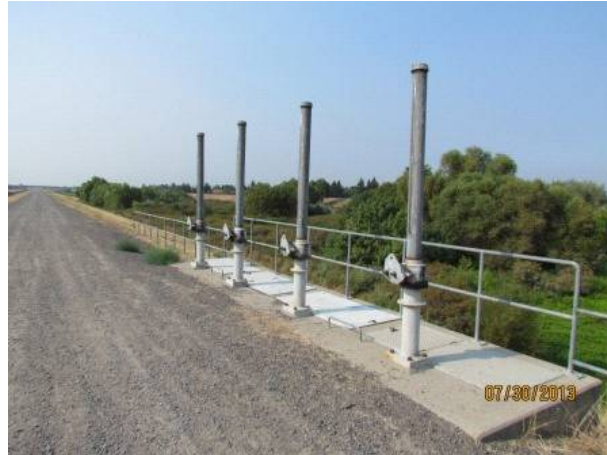
Levee Mile Report Line	16
Start Levee Mile	0.00
End Levee Mile	0.00
Location	
Category	Pump Stations
Item	Manual Gate Operators

View of the slide gate operators.

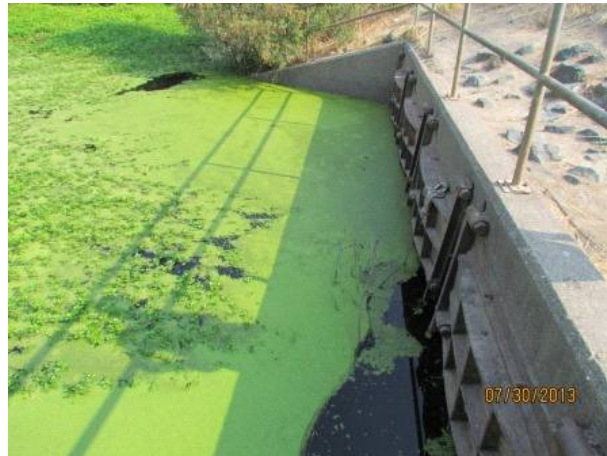
Levee Mile Report Line	18
Start Levee Mile	0.00
End Levee Mile	0.00
Location	
Category	Pump Stations
Item	Flap Gates

18	0.00	0.00	Pump Stations	Flap Gates		A	Item inspected visually only. Item was not operated during the inspection. Inspector Comments: The flap gates appeared to be in good condition and free of any obstructions.	38.640967 ° -121.471106 °	38.640967 ° -121.471106 °	19 Y
19	0.00	0.00	Pump Stations	Closure Structures		A	Item inspected visually only. Item was not operated during the inspection. Inspector Comments: Closure structures appeared to be in good condition.	38.640967 ° -121.471106 °	38.640967 ° -121.471106 °	20
20	0.00	0.00	Pump Stations	Security Fencing		A	Item inspected visually only. Item was not operated during the inspection. Inspector Comments: The security fencing around the structures appeared to be in good condition and should provide protection against unauthorized access.	38.640967 ° -121.471106 °	38.640967 ° -121.471106 °	21 Y

View of the flap gates.

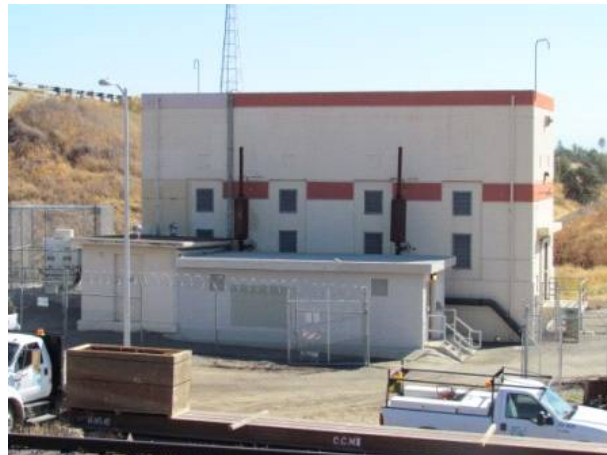
Levee Mile Report Line	20
Start Levee Mile	0.00
End Levee Mile	0.00
Location	
Category	Pump Stations
Item	Security Fencing

View of the security fencing around the structure.

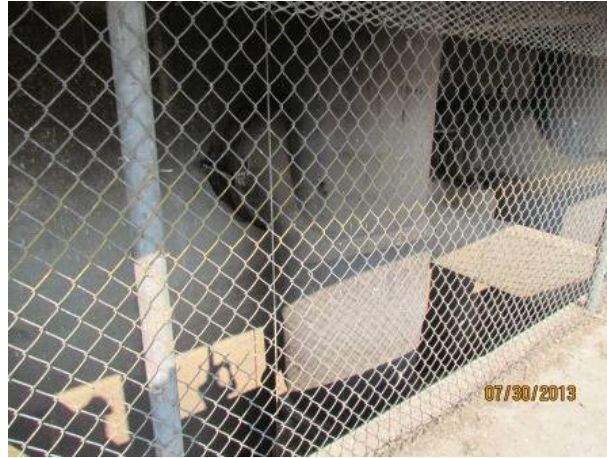
Levee Mile Report Line	21
Start Levee Mile	0.00
End Levee Mile	0.00
Location	
Category	Pump Stations
Item	Intake and Discharge Pipes

LMR No.	Levee Mile		Category	Item	Location *	Rating **	Action/Comment	GPS Latitude/Longitude		Issue No.
	Start	End						Start	End	Photo
21	0.00	0.00	Pump Stations	Intake and Discharge Pipes		A	Item inspected visually only. Item was not operated during the inspection. Inspector Comments: The intake pipes appeared to be in good condition.	38.640967 ° -121.471106 °	38.640967 ° -121.471106 °	22 Y

View of the intake pipes.
